Two case studies in which agricultural land retrocession led to land fragmentation and the arise of litigious situations

¹Ciprian S. Todoran, ^{2,3,4}I. Valentin Petrescu-Mag

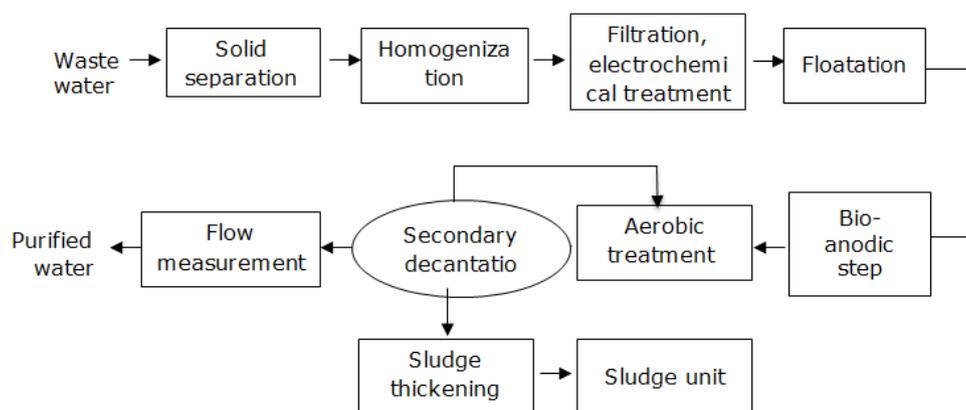
Figure 1. Technological scheme of waste water treatment.

At a sewage treatment plant the flow starts from the reception of waste water and ends with the sludge deposit and the removal of treated water (Panaitescu 2011), by carrying out the following technological operations:

- removal of coarse impurities (clarification), waste water basin, grates for retaining coarse waste. The grates are provided with scraping and emptying elevators. With the help of elevating scrapers, coarse waste is removed, collected in containers, and transported to the authorized landfill.
- waste water, via the waste water pumping station, passes into the compact grate, sand remover and grease separator units;
- then it passes into the water equalization and pumping basin towards the biological reactors from where, on two paths, it passes into the purified water compensation basin;
- after the discharge of waste water, a decisive technological phase in a sewage treatment plant is the technological management of the resulting sludge, passing through the following successive stages:
 - stabilization;
 - thickening;
 - mechanical drying.

All these operations and stages (Figure 1) represent a properly functioning sewage treatment plant and require a considerable area of land, an area that was not available to the Daia Română Administrative Territorial Unit from Alba County due to land fragmentation and their transfer to private ownership for other uses.

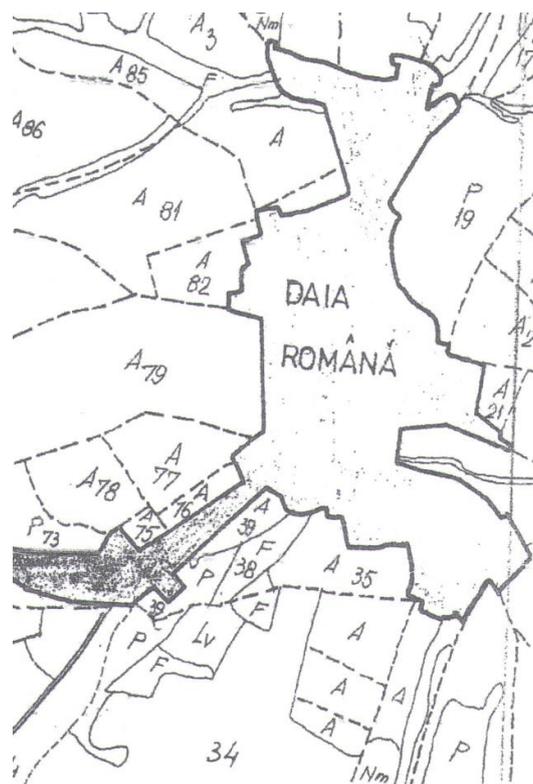
Figure 2. Extract from the General Plan - Water Management Authorization no. 99/2010 for the development of the Valea Daia Fish Farm (Water management authorization no. 99/2010).

Between the Daia Română (built-up area) commune and the fish farm, all the lands have been retroceded (Figure 2) with owners being natural persons or individual enterprises of agricultural interest or industrial production.

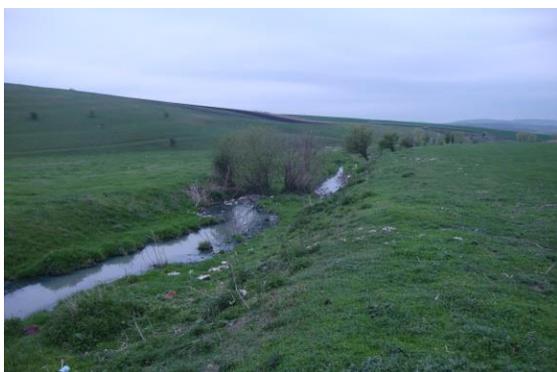
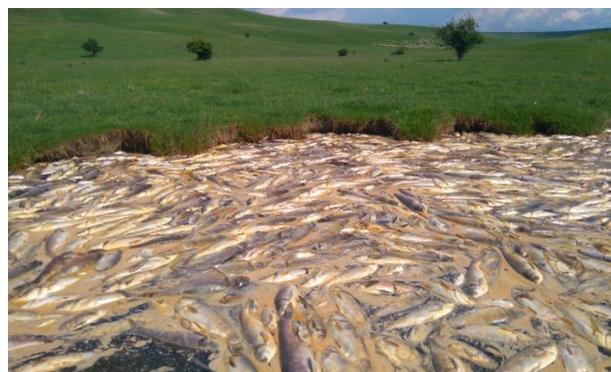
Figure 3. The Valea Daia stream feeding the pond; May 2017 – fish mortality.

Due to the lack of the necessary areas to create sludge storage tanks, sludge that had to be continuously evacuated, the slightest delay combined with the pluvial condition (weather conditions), led to a real ecological disaster. It should be mentioned that the sludge from the so-called "sludge platform", very limited in surface, due to lack of space, had to be evacuated at a distance of over 18 km (Water Management Authorization no. 99/2010). Thus, following rainy periods from April to May 2017, rainwater with considerable flow rates caused the sludge platform to be washed into the bed of the Valea Daia stream (outlet) and the pollution shock was discharged into the Daia 1 Pond (upstream), with an area of 35.5 ha of water, causing a fish mortality of almost 40.0 tons of fish (Figure 3), according to the documents drawn up by the specialized institutions (Expertise file no. 611/P/2021).

The event that occurred - the mortality of 40.0 tons of fish from Daia 1 Pond (upstream), caused by the discharge of water and sludge into the discharge (outlet) channel, as a result of the collection of waste water, the washing of the sludge platform by the rain, undoubtedly led to the triggering of some criminal investigations, expertise, trials in Courts regarding responsibilities, penalties, compensations. This, without taking into account the material damage caused to the fish farm (Expertise File no. 611/P/2021). All of this could have been prevented if there had been a surface of land downstream of the Daia fish farm, land belonging to the Daia Română Administrative Territorial Unit, on which the sewage treatment plant of the commune would have been located. The lack of analyses, as well as the lack of a crisis management plan caused by the incompatibility of the sewage treatment plant in achieving the objectives in full, for which the investment was invoked, produced a lot of harm, as can be seen from the multiple analyses and reports in the case file (Expertise File no. 611/P/2021).

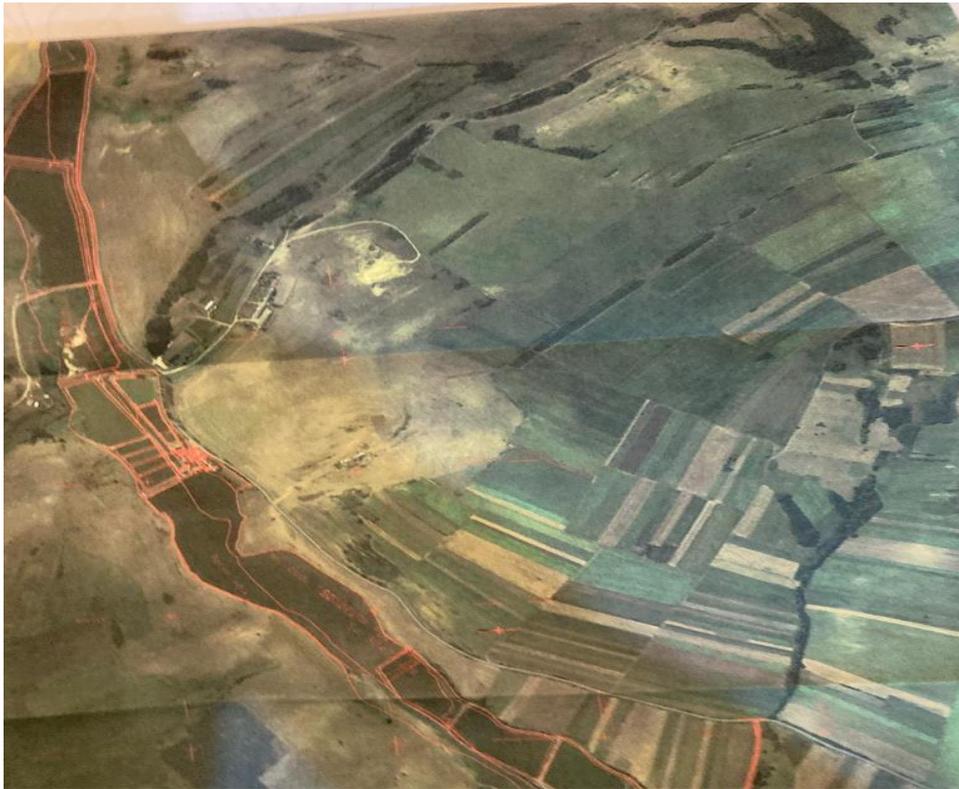
Figure 4. Daia Română locality, satellite map.

Following the satellite map provided by O.C.P.I and APIA (Expertise File no. 611/P/2021), it can be clearly seen that, following land transfers and the application of special laws, the entire area of land in the Daia Română Administrative Territorial Unit, whether it is urban or rural, between the area of houses and the Daia fish farm is fragmented into parcels, properties belonging to natural persons.

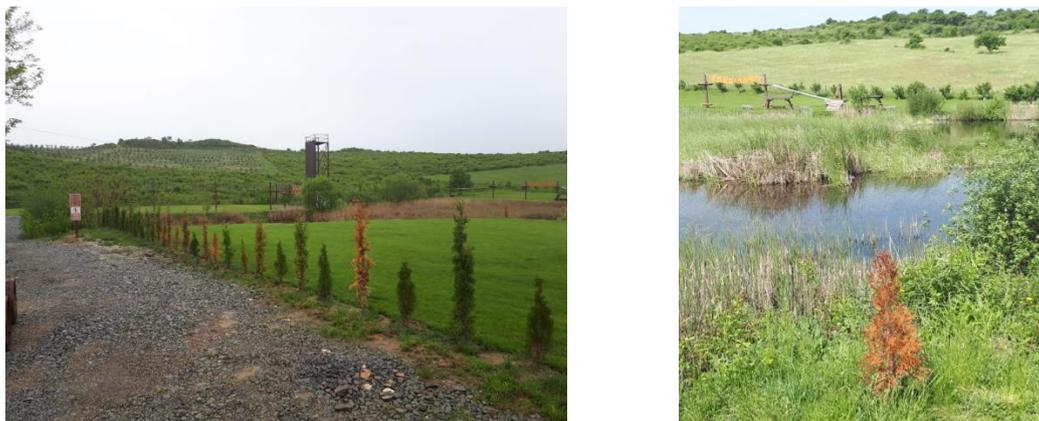
Figure 5. Expertise images from 2021 from the Fruit farm-Fish pond arrangement from Sigmir (Bistrita).

The water accumulation made up of three basins of different sizes, had a double role:

- as a primary role - water reserve for fruit tree irrigation in accordance with the prescribed technologies;
- as a secondary role – stocking with fish, also becoming a recreational area over time.

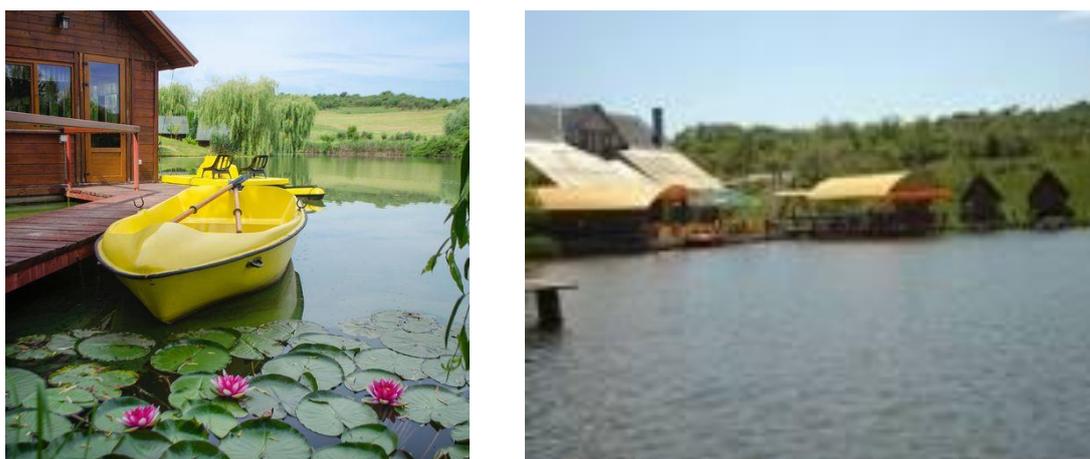
Figure 6. The Sigmir fish farm (Source: www.pescuitul.eu).

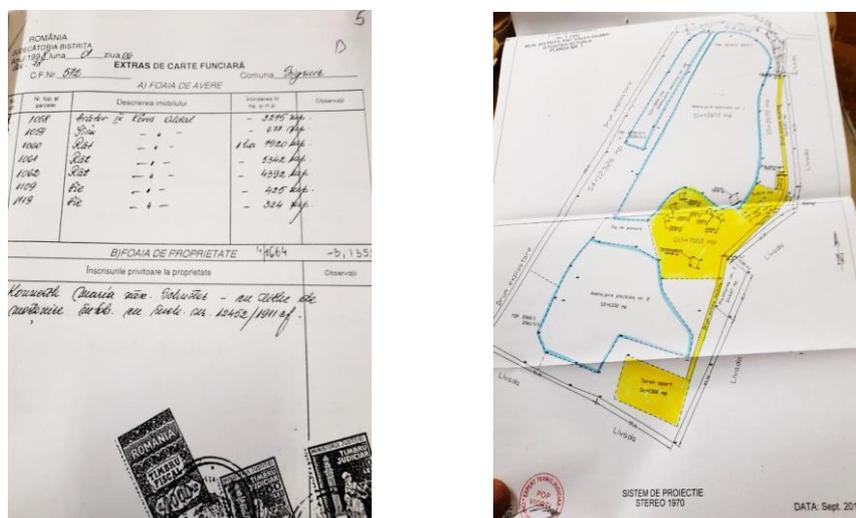
Figure 7. Land register extract from 1998; Situation plan made by an expert in 2010.

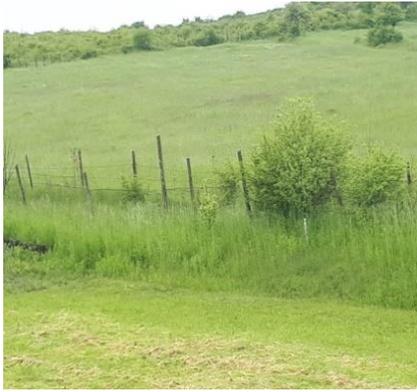
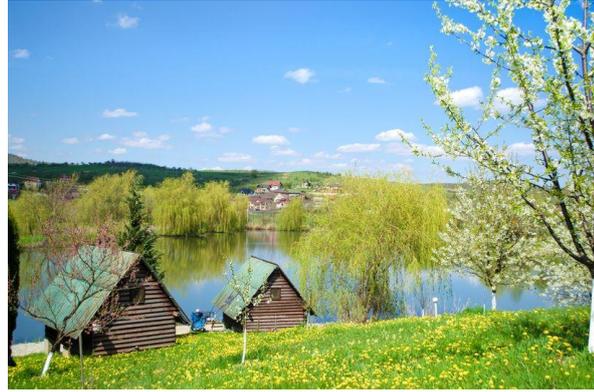
Figure 8. Expertise images from 2021 from the Sigmir Fruit - Fish farm (Bistrița).
